# Structural Survey Report

"Out of Reach"  
34 Brighton Hill Road  
Devonshire

Mason and Associates Ltd.  
November 13, 2018

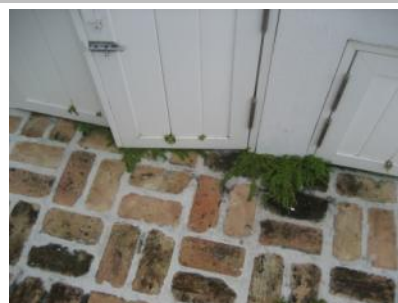
The south patio was generally in satisfactory condition. Vegetation growing out of the deck should be removed to prevent any damage to the brick or mortar joints.

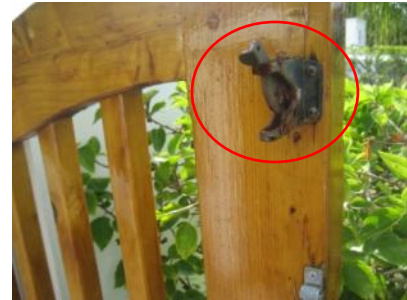
The gate was generally in satisfactory condition. Surface corrosion was observed on the gate hardware.

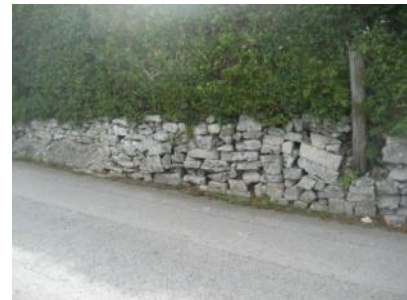
The retaining walls were generally in satisfactory condition. The west Bermuda stone retaining wall had vertical cracks but was plumb. The dry stone wall on the north side of the property generally appeared to be in satisfactory condition. A portion near the northeast corner of the property did not appear to be plumb and stones appeared to be shifted out of place. The section should be repaired to ensure that it remains in place.

| Scope of Remedial Work and Upgrades | Prelim<br>Budget Est. |
|---|---|
| Repair north boundary wall | \$800 |

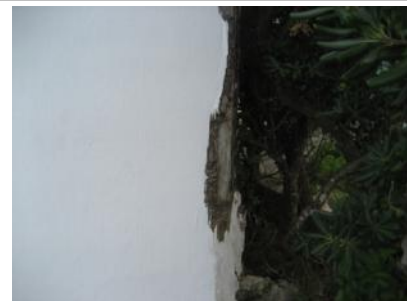
There was evidence of damage from wood boring insects in the frame of the wooden structure on the south side of the property.

| Scope of Remedial Work and Upgrades | Prelim<br>Budget Est. |
|---|---|
| Repair south shed (treat termites) | \$800 |

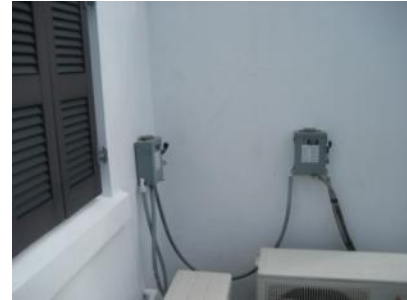
The walls were plumb with no indications of immediate structural distress. Some minor hairline cracking was observed on the south side of the house.

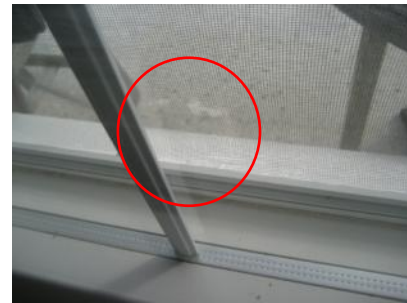
The windows were generally in satisfactory condition. A representative number of windows were tested and operated correctly. Damaged screens were observed on east and west windows.

| Scope of Remedial Work and Upgrades | Prelim<br>Budget Est. |
|---|---|
| Repair screens | \$50 |

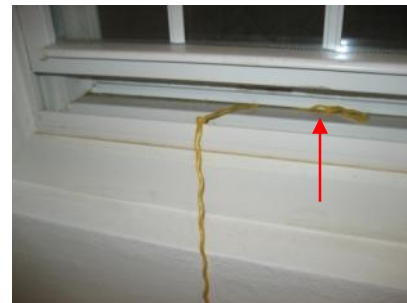
The shutters generally appeared to be in satisfactory condition. The shutter in the lower bathroom did not appear to be securely shut and had been temporarily secured.

| Scope of Remedial Work and Upgrades | Prelim<br>Budget Est. |
|---|---|
| Repair lower shutter | \$100 |

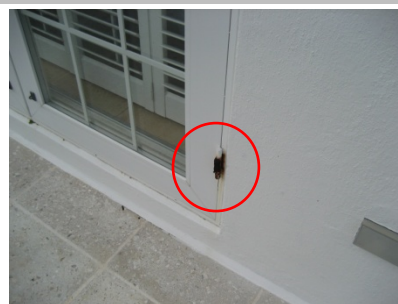
The exterior doors were generally in satisfactory condition. The hinges on the master bedroom French door were corroding. This condition was not observed on the single door on the east side of the house.

| Scope of Remedial Work and Upgrades | Prelim<br>Budget Est. |
|---|---|
| Repair/replace French door hardware | \$600 |

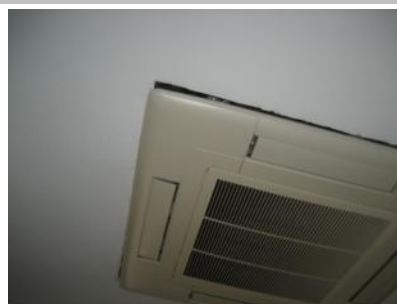
The ceilings were generally in satisfactory condition. A gap was observed around the AC unit in the kitchen. This is likely due to misalignment of the unit following maintenance. The unit should be realigned to seal the ceiling.

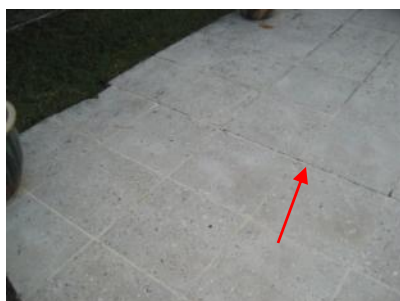
The deck was generally in satisfactory condition. Some hairline cracking was observed.

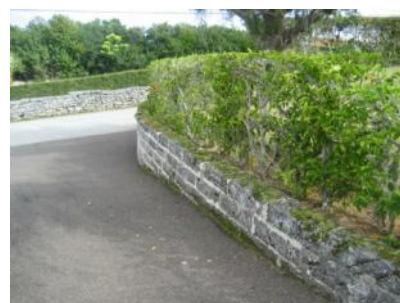
North boundary wall.

A section of wall near the northeast corner of the property did not appear to be plumb.

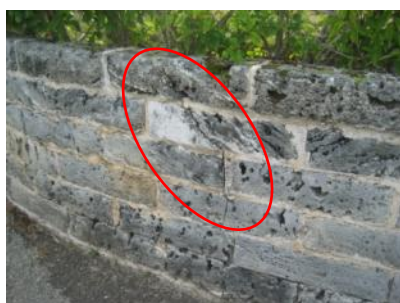
Some vertical cracking was observed in the stone wall but the wall was plumb with no indications of significant movement.

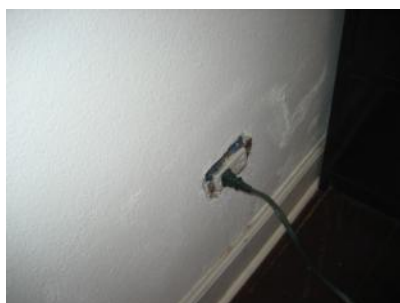
Efflorescence was visible on the east wall.

Efflorescence was observed in the lower bedroom, master bedroom and hallway. The area should be cleaned of paint and completely dried. The walls should then be primed with an alkali resistant rubberized primer and painted with a latex top coat paint.

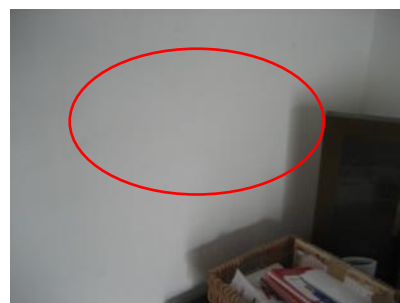
Minor hairline cracks were observed on the west wall of the bedroom.

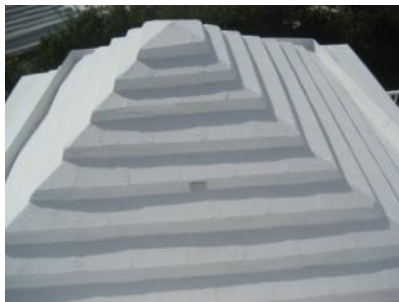
Minor debris accumulation in the valley between roofs.

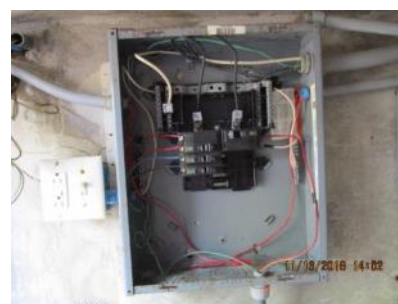
**3.4** A 100A 120/240V 06 CCT distribution panel located in the pool equipment room appeared generally sound. However, the panel is starting to rust. Recommend sanding and painting.

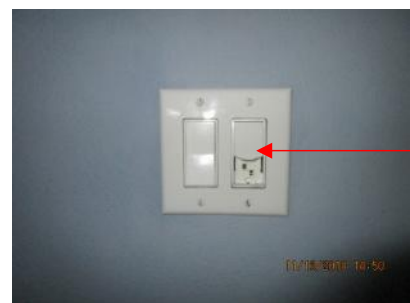
**4.77** Combo switch is broken; needs replacing.
