# Structural Survey Report

"Out of Reach"  
34 Brighton Hill Road  
Devonshire

Mason and Associates Ltd.  
November 13, 2018

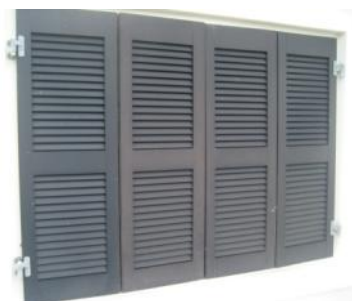
The shutters generally appeared to be in satisfactory condition.

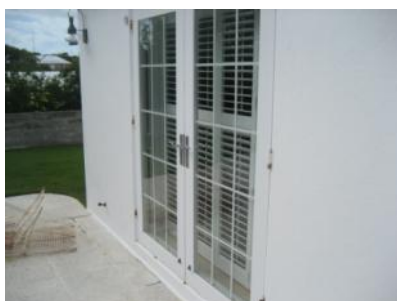
Corroded hinges and hardware were observed on the south French doors.

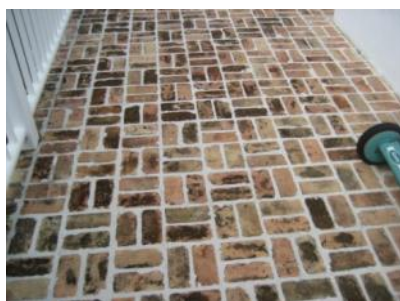
South patio was generally in satisfactory condition.

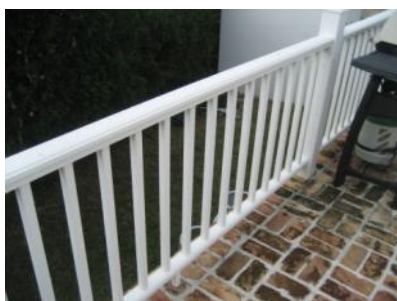
Railing was in satisfactory condition.

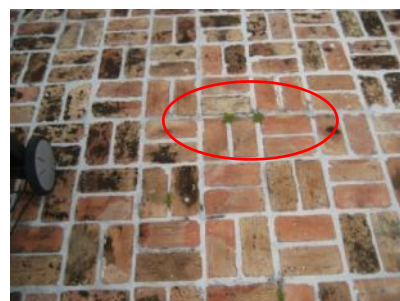
Vegetation growing in the deck should be removed.

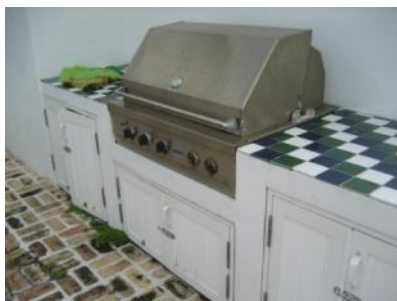
Barbeque on the west porch was not tested. A couple of controls knobs were missing.

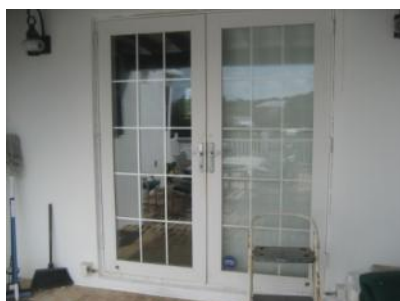
French doors were in satisfactory condition.

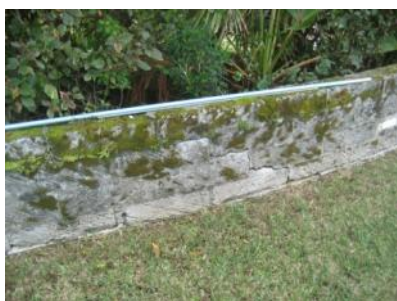
East boundary wall was in satisfactory condition.

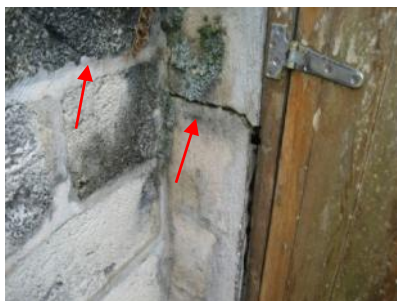
Crack was observed extending into the interior of the pump room along the south wall.

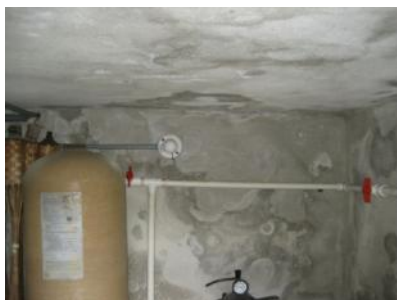
Ceiling appeared to be in satisfactory condition.

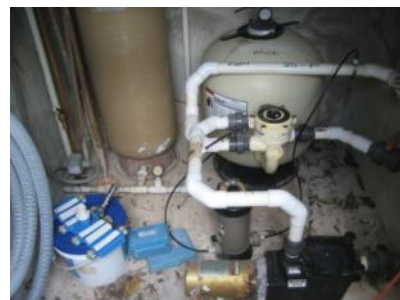
Equipment appeared to be in satisfactory condition.

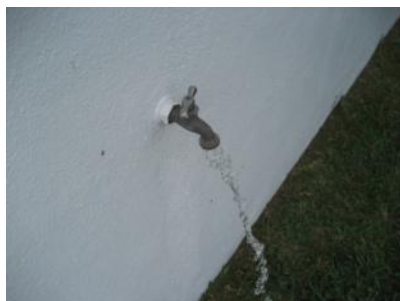
Exterior north faucet tested satisfactorily.

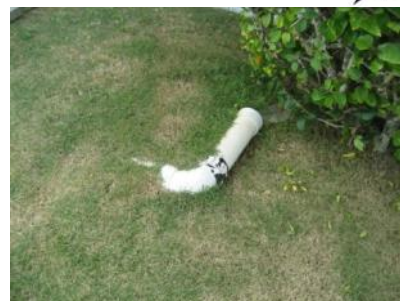
Tank overflow was observed in the north yard.

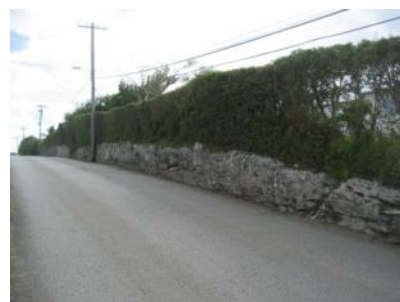
North boundary wall was generally in reasonable condition.

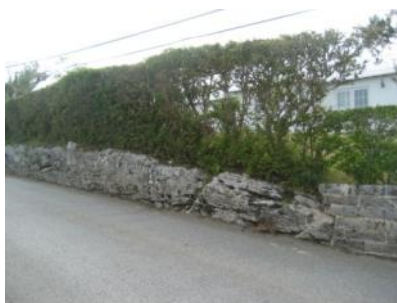
North boundary wall.

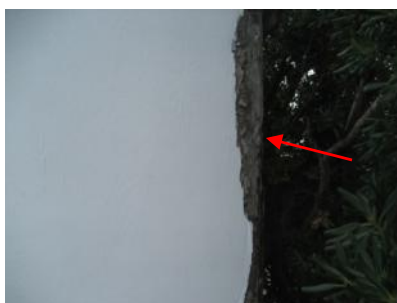
Damage from wood boring insects on the southwest corner of the shed.

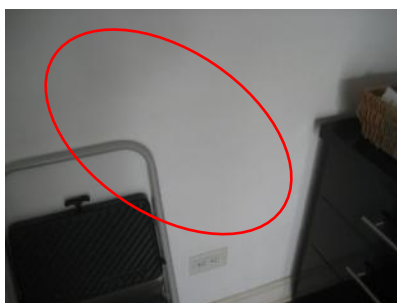
Minor hairline cracks were observed on the west wall of the bedroom.

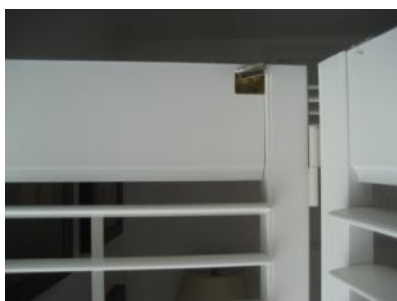
A damaged magnetic latch was observed in the right side of the door.

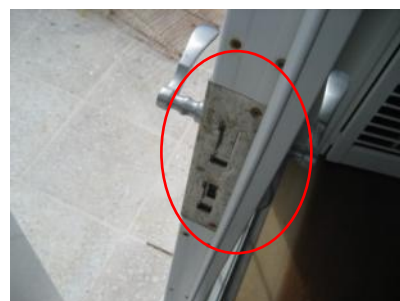
Corroded hardware on the French doors.

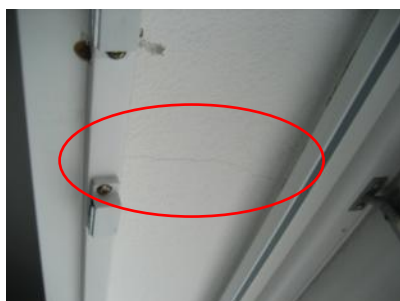
Minor hairline crack was observed in the lintel over the French doors.

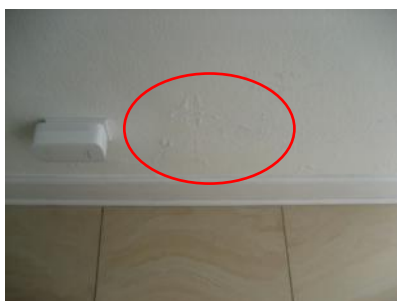
Small amount of efflorescence on the hallway wall.

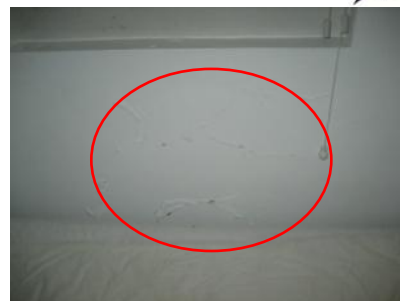
Efflorescence was observed on the south wall of the bedroom.

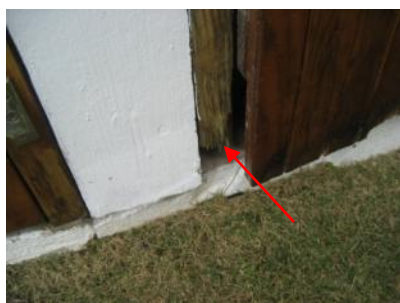
Deteriorated wood frame for the pump room.

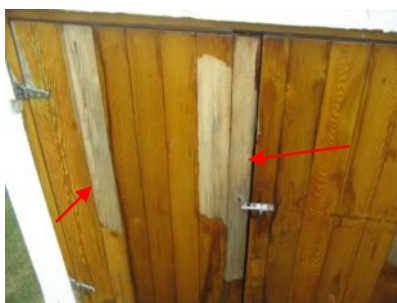
Finish on pump room door was deteriorated. The finish should be restored to protect the wood from deterioration.

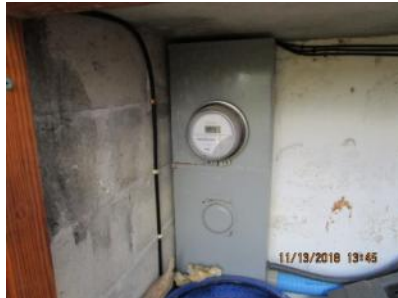
**1.1 Service Entrance (Belco Meter) (BTC)**

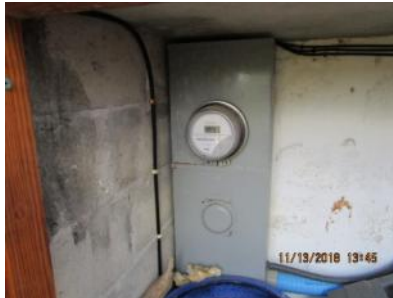
**1.2** The residence is supplied with a 200A 120/240V single-phase service located in an exterior utility room west side of the residence. The metered service appeared generally sound.

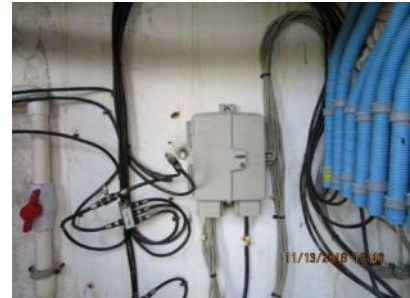
**1.3** The incoming BTC terminal box appeared generally sound.

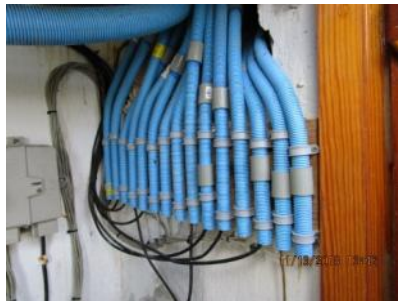
**1.4** The Cable/ Data wiring appeared generally sound.

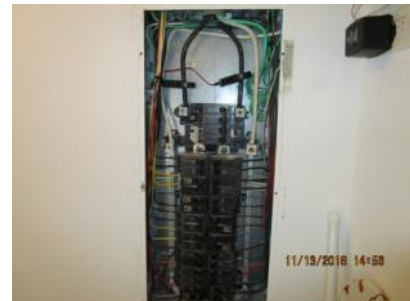
**2.2** A 200A 120/240V 32 CCT distribution panel located in the laundry appeared generally sound.

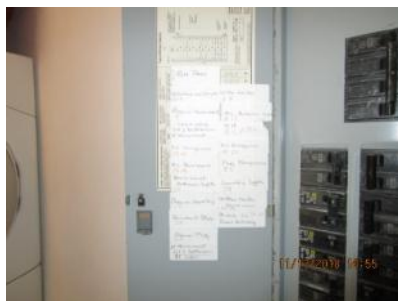
**2.3** Panel directory was complete; appeared accurate.

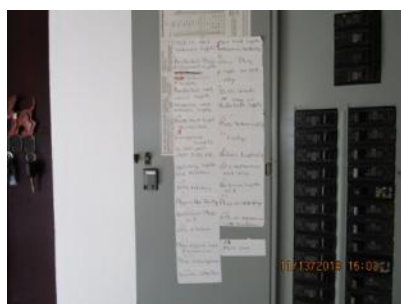
**3.3** Panel directory was complete; appeared accurate.

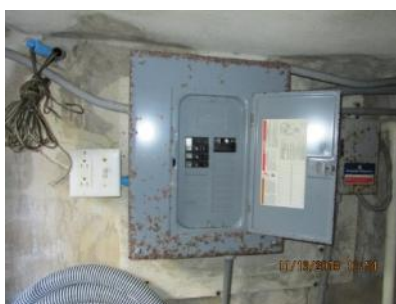
**3.4** A 100A 120/240V 06 CCT distribution panel located in the pool equipment room appeared generally sound. However, the panel is starting to rust. Recommend sanding and painting.

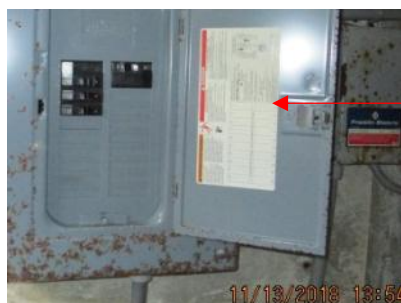
**3.6** Panel directory needs to be completed.

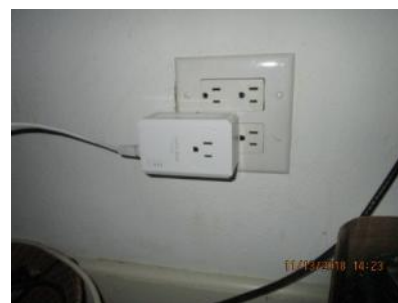
**4.2** Receptacle outlets west (W) appeared generally sound.

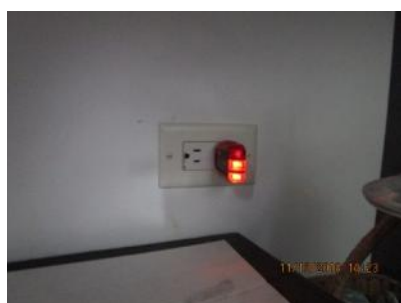
**4.3** Receptacle outlet east (E) appeared generally sound.

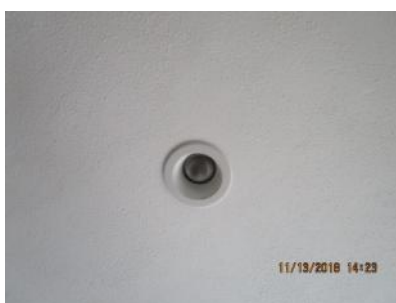
**4.4** Recess fixtures appeared generally sound.

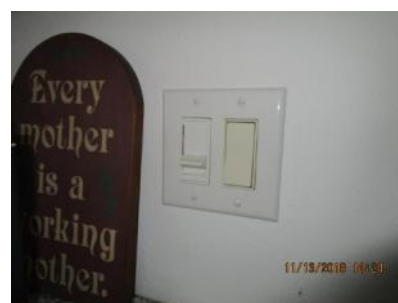
**4.5** Switch appeared generally sound. The dimmer however, is faulty.

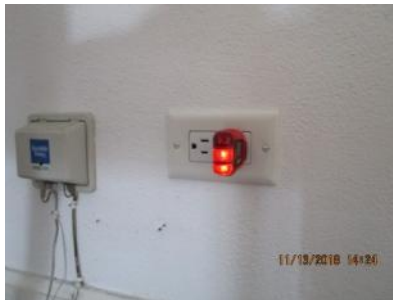
**4.7** Receptacle outlet (E) appeared generally sound.

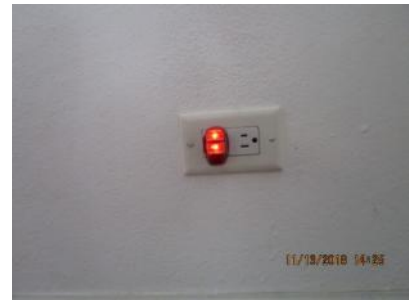
**4.8** Receptacle outlet (W) appeared generally sound.

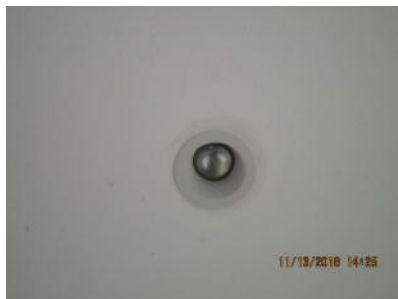
**4.9** Recess fixtures appeared generally sound.

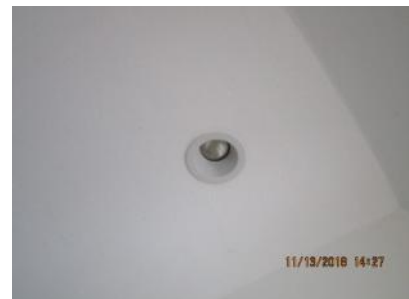
**4.11** Recess fixtures appeared generally sound.

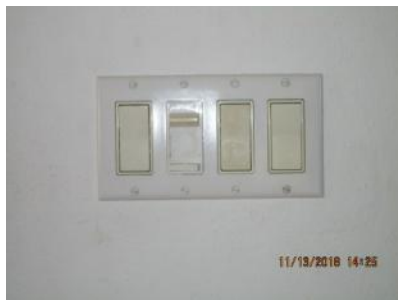
**4.12** Switches appeared generally sound.

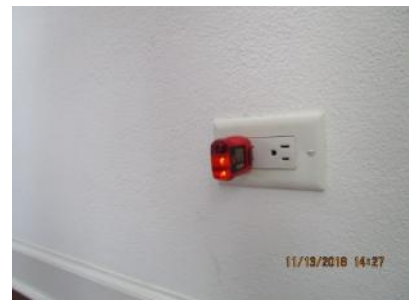
**4.14** Receptacle outlet south (S) appeared generally sound.

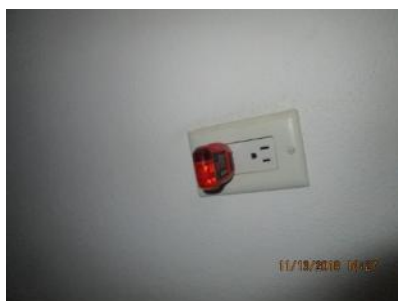
**4.15** Receptacle outlet south (W) appeared generally sound.

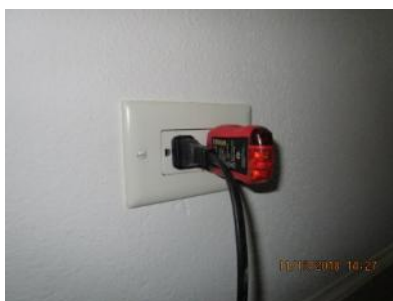
**4.16** Receptacle outlet north (N) appeared generally sound.

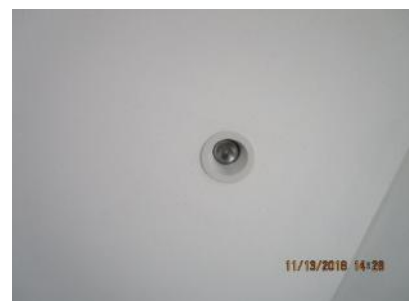
**4.17** Recess fixtures appeared generally sound.

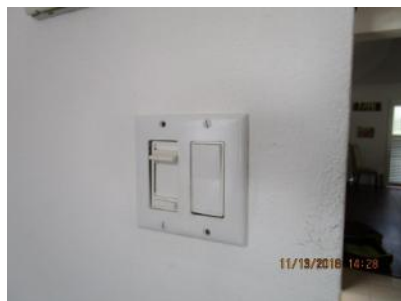
**4.18** Switches appeared generally sound.

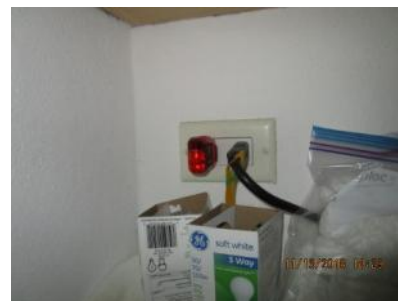
**4.20** Counter receptacle outlet appeared generally sound.

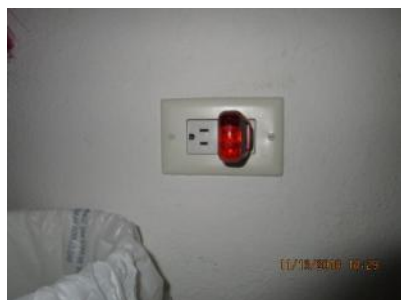
**4.21** Receptacle outlet (S) appeared generally sound.

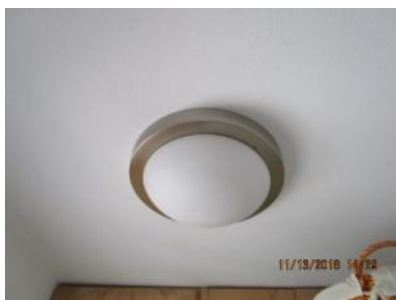
**4.22** Fixture appeared generally sound.

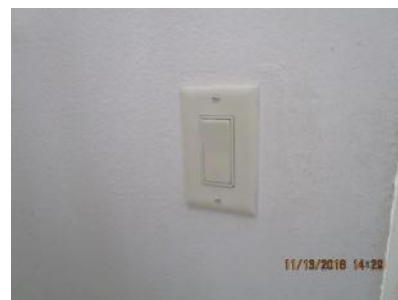
**4.23** Switch appeared generally sound.

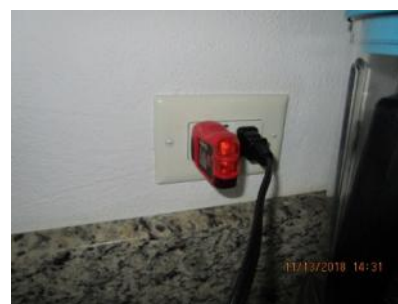
**4.26** Counter GFCI receptacle outlet (E) tested ok; appeared generally sound.

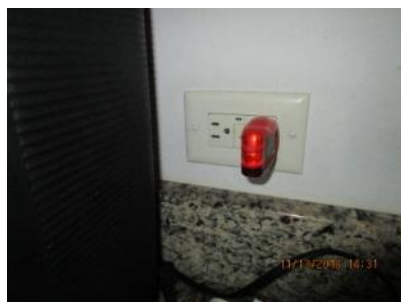
**4.27** Counter GFCI receptacle outlet (E) tested ok; appeared generally sound.

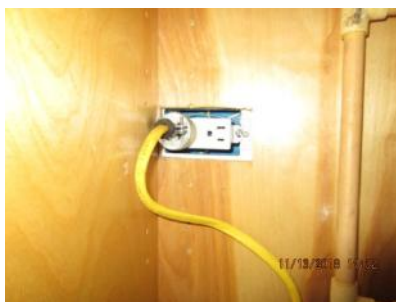
**4.28** Under cabinet receptacle requires a cover plate.

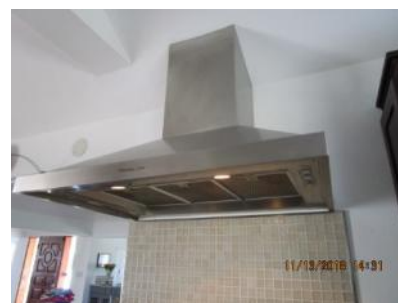
**4.32** Exhaust hood tested ok; appeared generally sound.

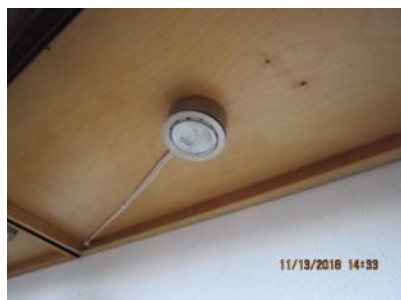
**4.33** Under cabinet fixtures appeared generally sound.

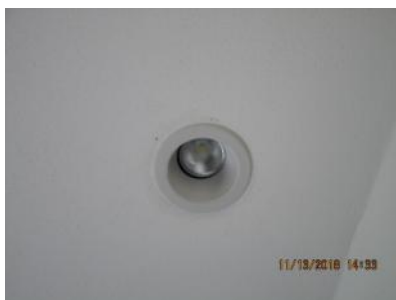
**4.34** Recess fixtures appeared generally sound.

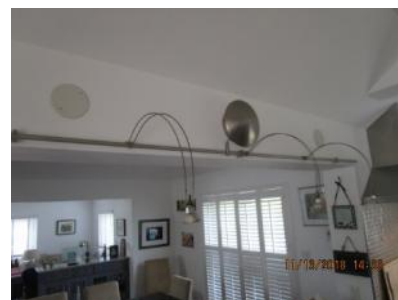
**4.35** Wall fixture appeared generally sound.

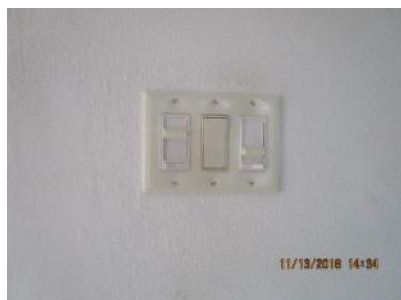
**4.36** Switches appeared generally sound.

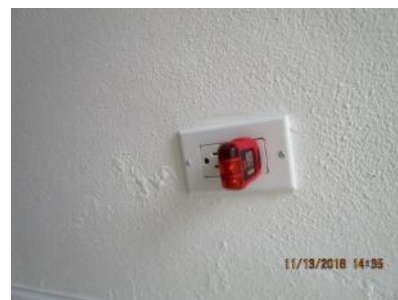
**4.38** Receptacle outlets appeared generally sound.

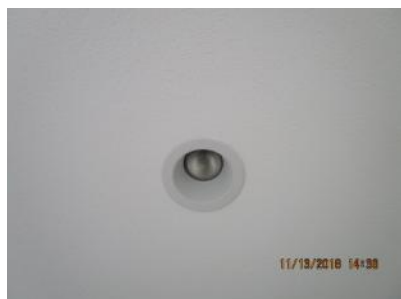
**4.39** Recess fixtures appeared generally sound.

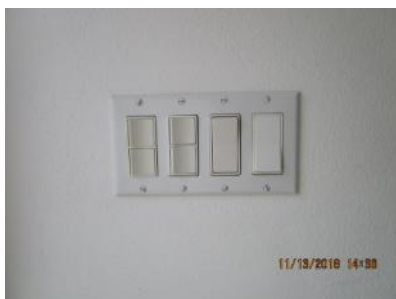
**4.40** Switches appeared generally sound.

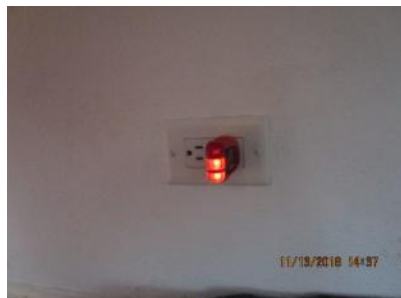
**4.42** Receptacle outlet (N) appeared generally sound.

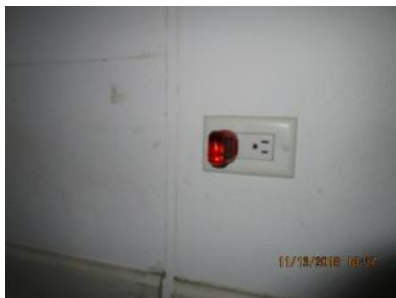
**4.43** Closet receptacle outlet appeared generally sound.

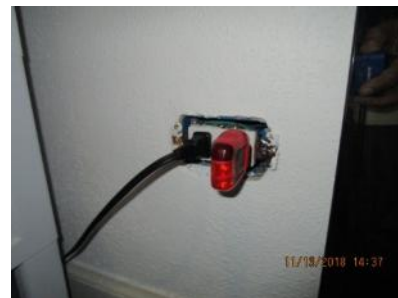
**4.44** Receptacle outlet (E) requires a cover plate.

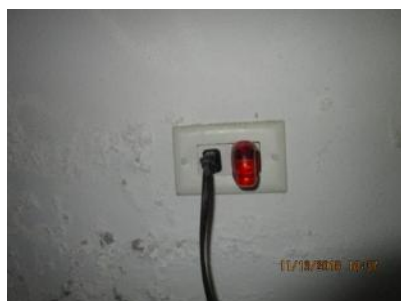
**4.45** Receptacle outlet (W) appeared generally sound.

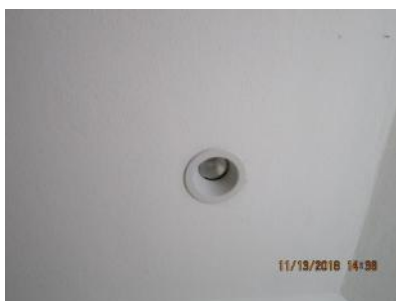
**4.46** Recess fixtures appeared generally sound.

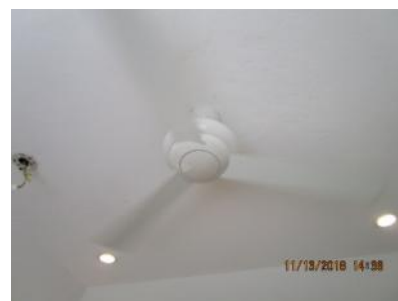
**4.47** Ceiling fan appeared generally sound.

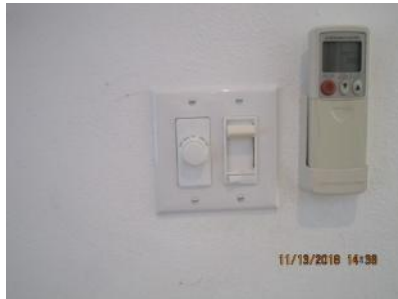
**4.48** Switches appeared generally sound.

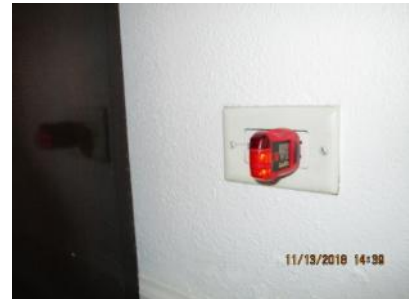
**4.50** Receptacle outlet (E) appeared generally sound.

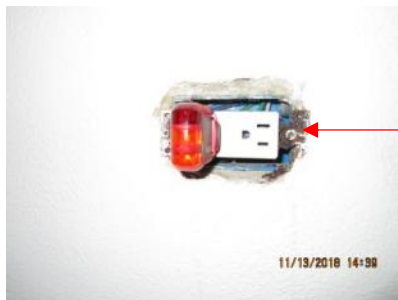
**4.51** Receptacle device (W) requires replacement as the device strap has rusted away.

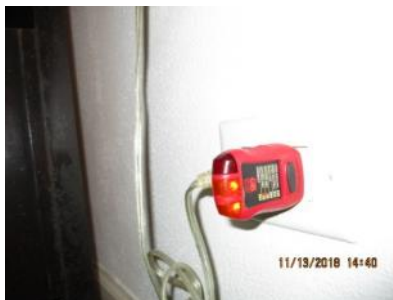
**4.52** Receptacle outlet (S) appeared generally sound.

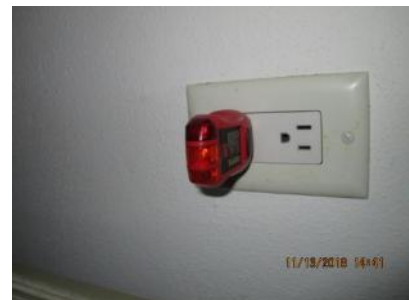
**4.53** Receptacle outlet (N) displays a reversed polarity (HOT/NEU); needs correcting.

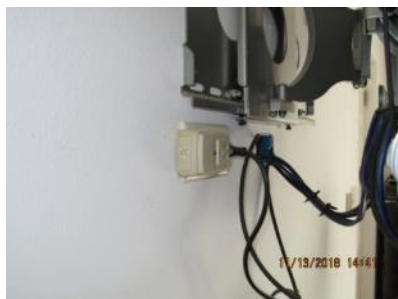
**4.54** Receptacle outlet (E) appeared generally sound.

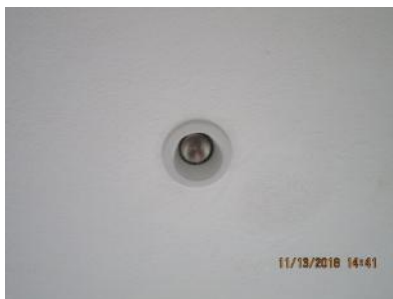
**4.55** Recess fixtures appeared generally sound.

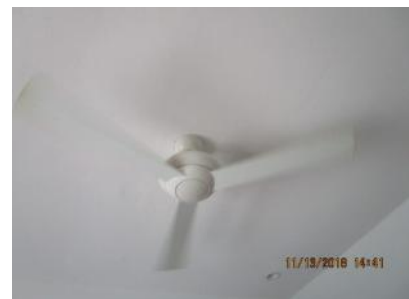
**4.56** Ceiling fan appeared generally sound.

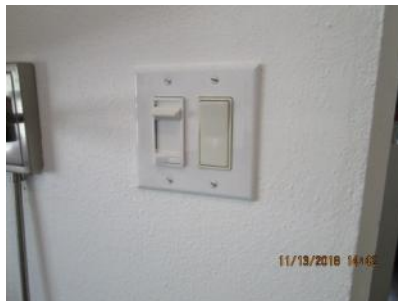
**4.57** Switches appeared generally sound.

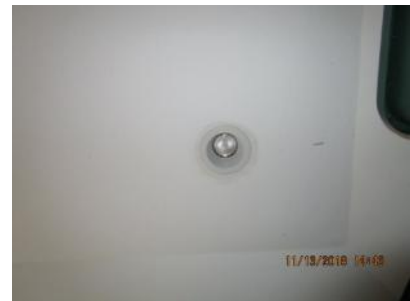
**4.59** Exposed bulbs not permitted in clothes closets.

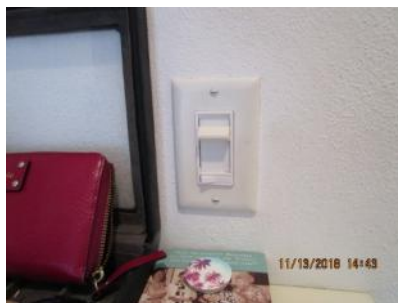
**4.60** Switch appeared generally sound.

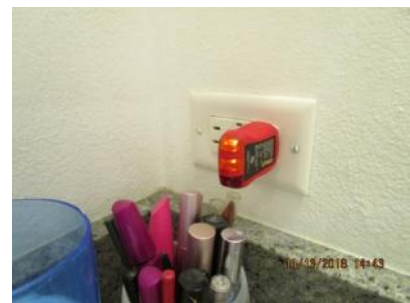
**4.62** GFCI receptacle outlet tested ok; appeared generally sound.

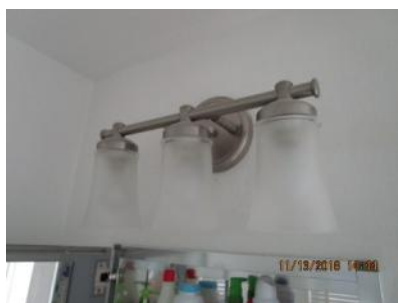
**6.63** Fixture appeared generally sound.

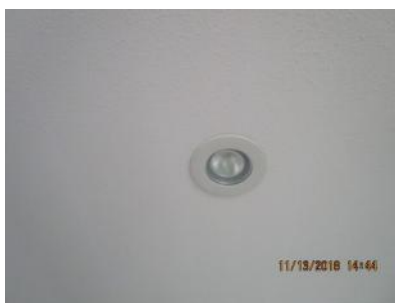
**4.64** Recess fixtures appeared generally sound.

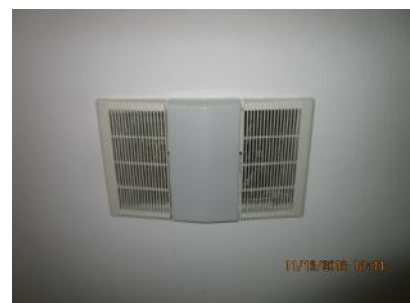
**4.65** Heat, Vent, Light tested ok; appeared generally sound.

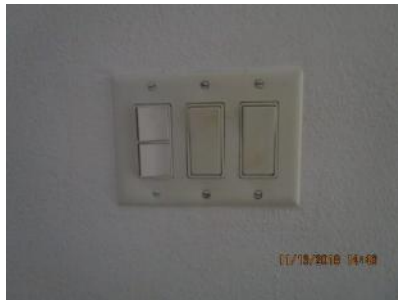
**4.66** Switches appeared generally sound.

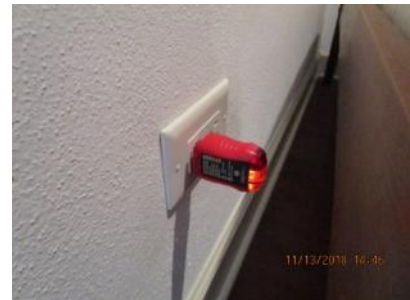
**4.68** Receptacle outlet (W) appeared generally sound.

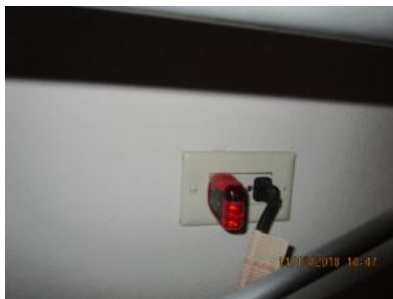
**4.69** Data; Receptacle outlet (N) appeared generally sound.

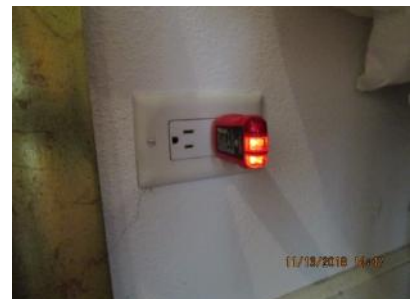
**4.70** Receptacle outlet (E) appeared generally sound.

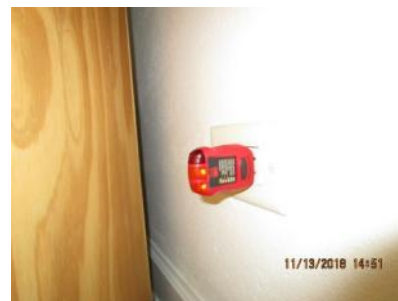
**4.79** Receptacle outlet (S) appeared generally sound.

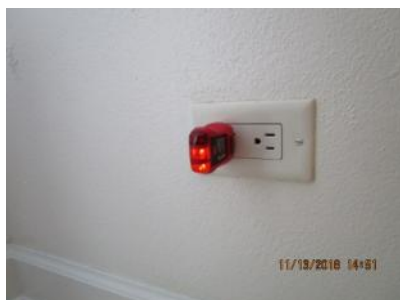
**4.80** Receptacle outlet (W) appeared generally sound.

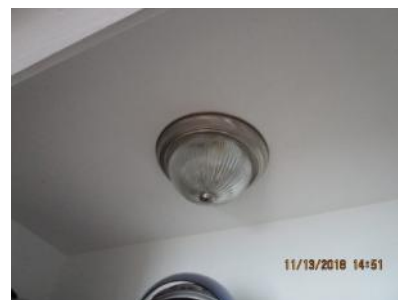
**4.82** Recess fixtures appeared generally sound.

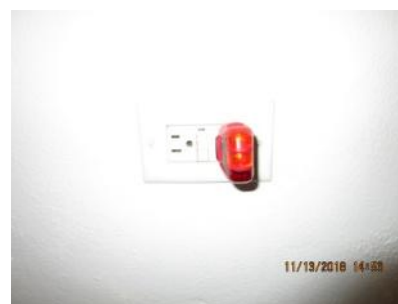
**4.85** Vanity GFCI receptacle outlet tested ok; appeared generally sound.

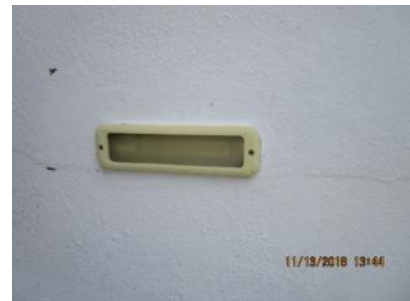
**4.91** Recessed louvered fixtures (N) appeared generally sound.

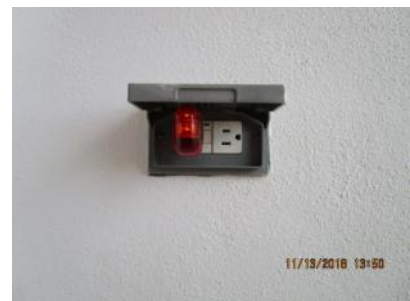
**4.94** GFCI receptacle outlet (E) tested ok; appeared generally sound.

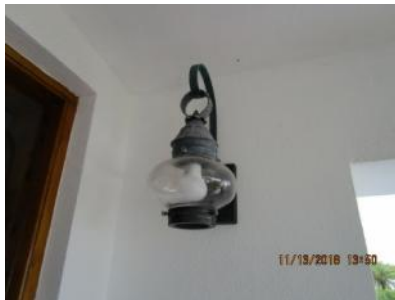
**4.96** Main entry fixtures appeared generally sound.

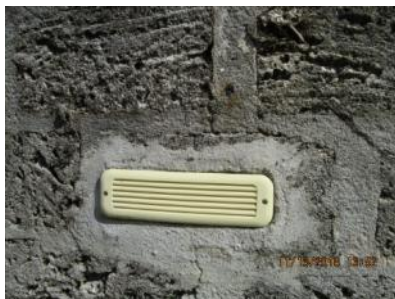
**4.99** Recessed louvered fixtures (S) appeared generally sound.

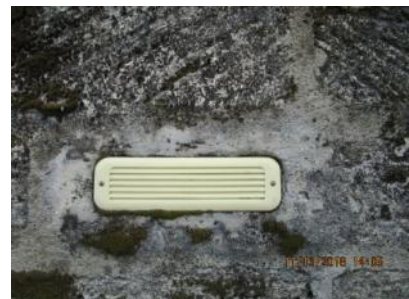
**4.100** Recessed louvered fixtures (S) appeared generally sound.

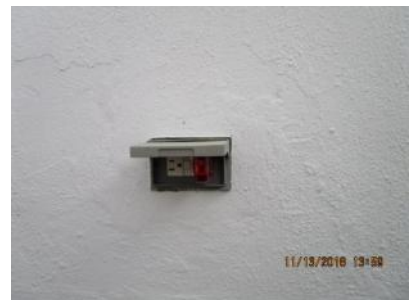
**4.103** GFCI receptacle outlet (W) tested ok; appeared generally sound.

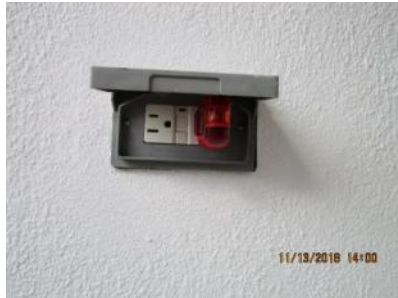
**4.104** GFCI receptacle outlet (W) tested ok; appeared generally sound.

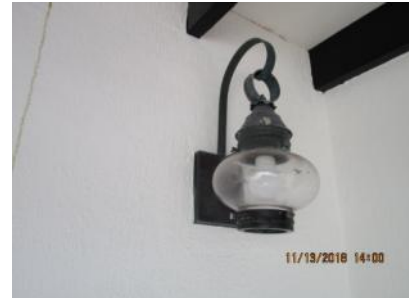
**4.106** Fixture (W) appeared generally sound.

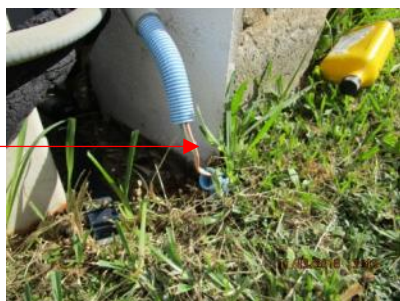
**7.4** The E.N.T. conduit (Smurf Pipe) seen here is broken due to physical damage likely from a weed whacker exposing the live conductors. E.N.T. is not permitted by code to be installed in like areas; should be replaced with a more durable type conduit.

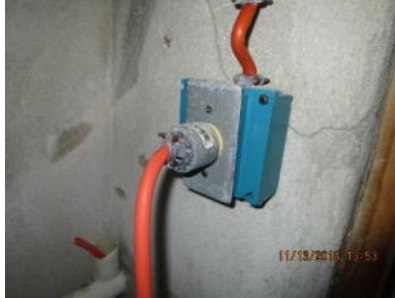
**7.20** Receptacle outlet appeared generally sound.

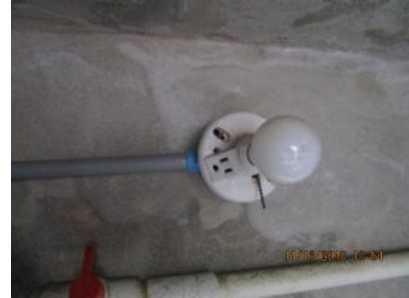
**7.21** Fixture appeared generally sound, **However, needs a new bulb.**
