# Structural Survey Report

"Out of Reach"  
34 Brighton Hill Road  
Devonshire

Mason and Associates Ltd.  
November 13, 2018

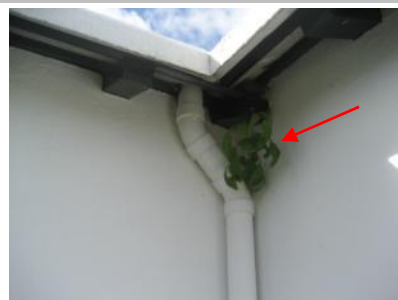
The gutters and downspouts were generally in satisfactory condition. Vegetation was observed growing out of a downspout on the north side of the house.

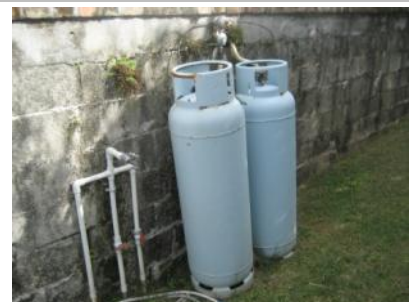
The fuel tanks appeared to be in satisfactory condition but should be inspected by a qualified technician to confirm their condition.

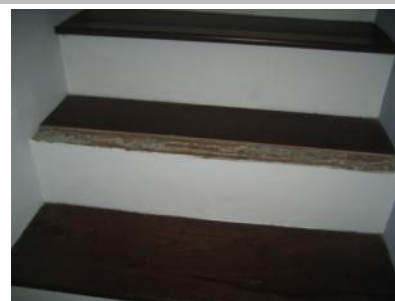
The stairs were in satisfactory condition. A step was missing the wood molding.

| Scope of Remedial Work and Upgrades | Prelim<br>Budget Est. |
|---|---|
| Repair wood molding for stairs | \$50 |

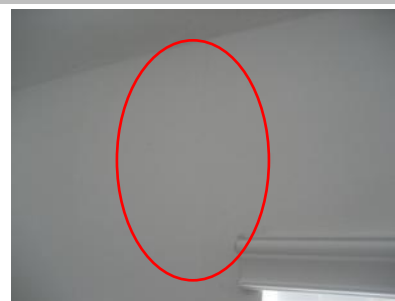
The walls were generally in satisfactory condition. Minor cracks were observed in the east bedroom wall.

| Scope of Remedial Work and Upgrades | Prelim<br>Budget Est. |
|---|---|
| Repair and paint walls as necessary | \$700 |

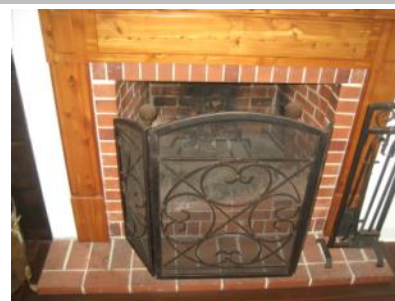
The fireplace appeared to be in satisfactory condition but should be inspected by a qualified chimney sweep.

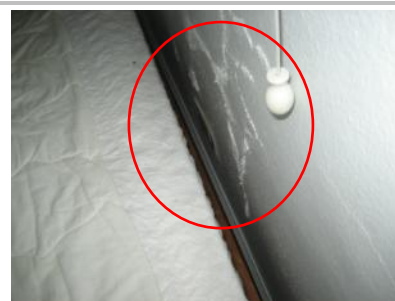
Efflorescence was observed in the lower bedroom, master bedroom and hallway. The area should be cleaned of paint and completely dried. The walls should then be primed with an alkali resistant rubberized primer and painted with a latex top coat paint.

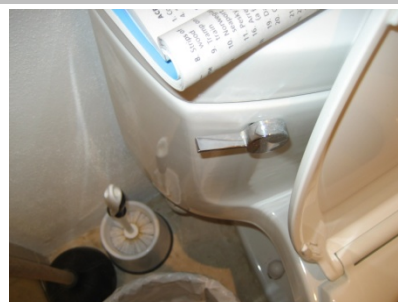
The toilet flushed and filled satisfactorily when tested. The flush lever was loose and requires adjustment.

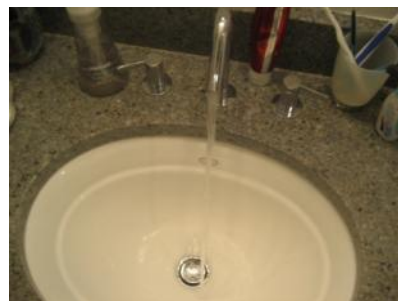
The sink flow and drain tested satisfactorily.

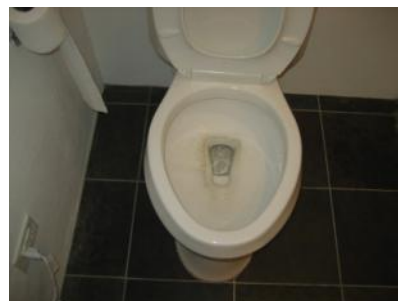
The toilet flushed and filled satisfactorily when tested.

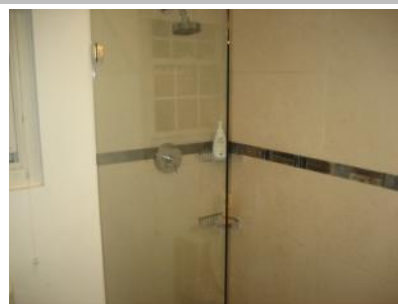
The shower flow and drain tested satisfactorily.

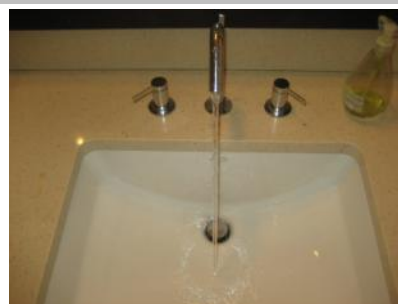
The sink flow and drain tested satisfactorily.

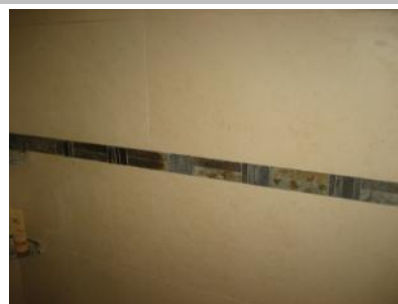
The shower walls were in satisfactory condition.

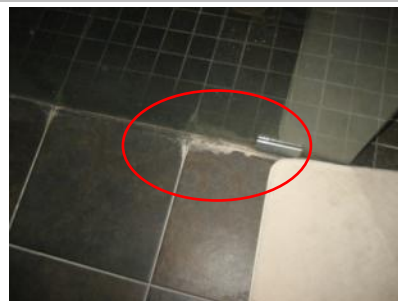
The floor was in satisfactory condition. Some efflorescence was observed near the shower.

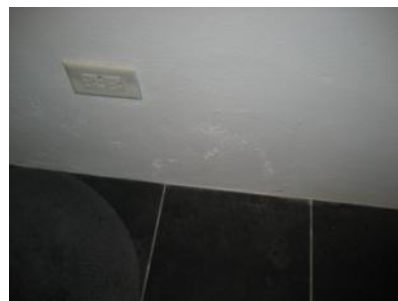
Efflorescence was observed on the bathroom wall.

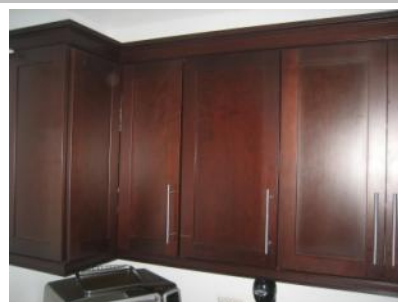
The cabinets were in satisfactory condition.

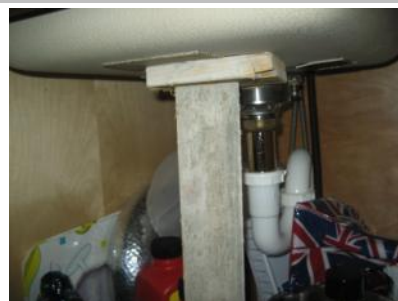
The sinks flow and drain tested satisfactorily. A wood prop was observed under the prep sink. The sink should be securely connected to the underside of the counter top.

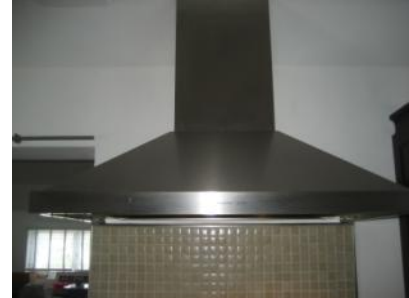
The vent fan operated correctly when tested.

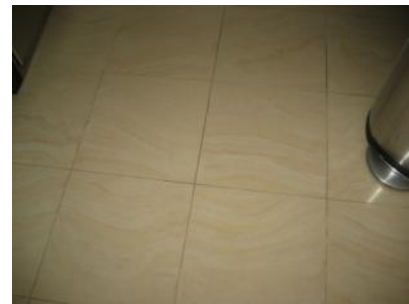
The floor was in satisfactory condition.

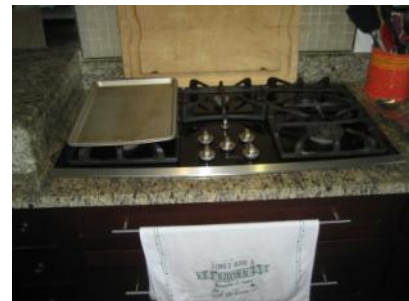
The stove and oven appeared to be in satisfactory condition but should be inspected by a qualified appliance technician to confirm that they operate correctly.

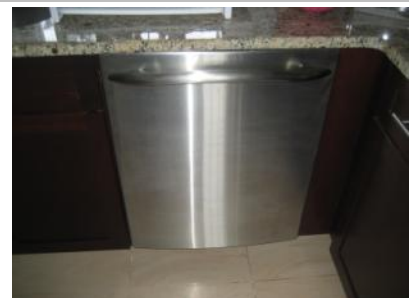
The dishwasher appeared to be operating correctly when inspected.

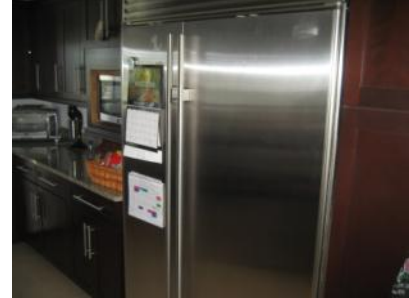
The refrigerator was operating during the inspection.

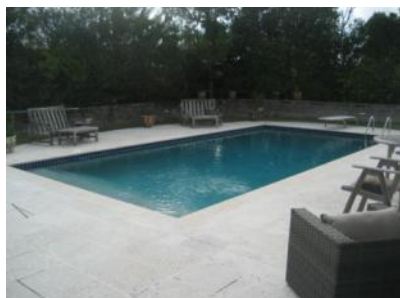
The pool appeared to be in satisfactory condition.

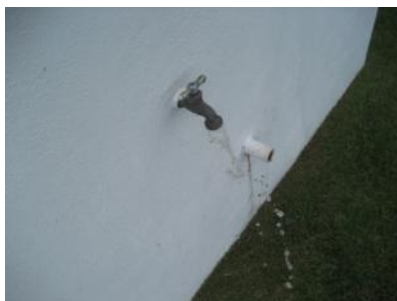
Exterior north faucet tested satisfactorily.

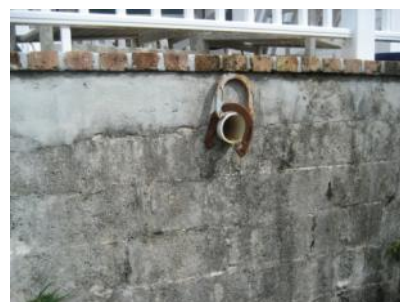
There appeared to be an overflow but it was not clear whether this was in use.

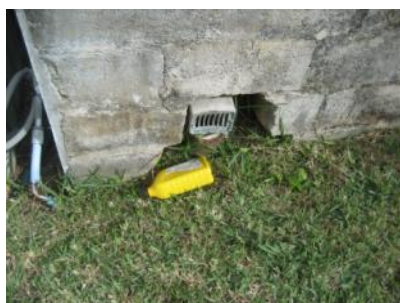
An old cess pit vent was visible at the bottom of the south patio wall.

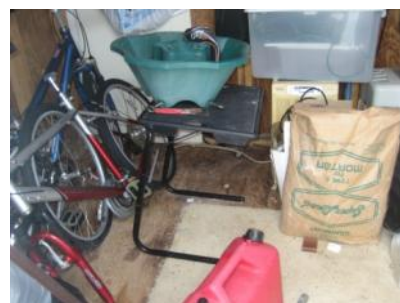
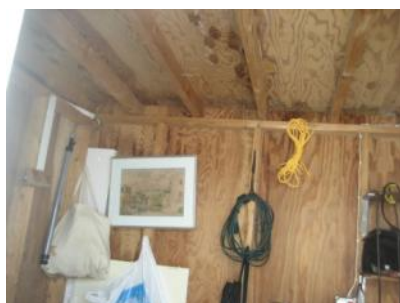
Damage from wood boring insects on the southwest corner of the shed.

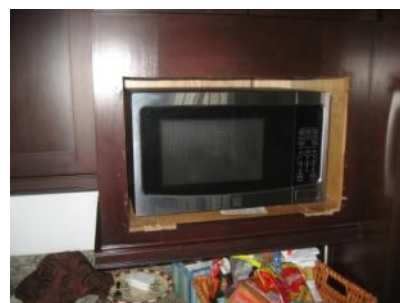
There appeared to have originally been a larger microwave in the cabinet.

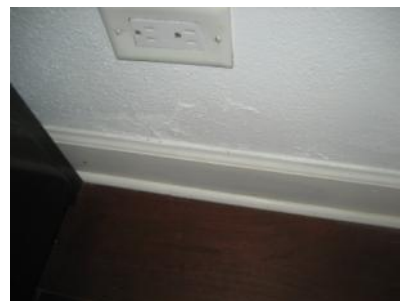
Efflorescence was visible on the east wall.

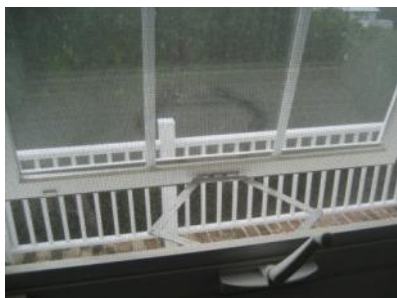
Awning window operated correctly when tested.

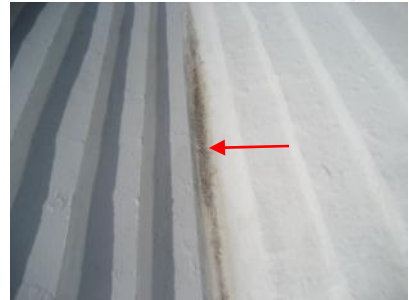
Minor debris accumulation in the valley between roofs.

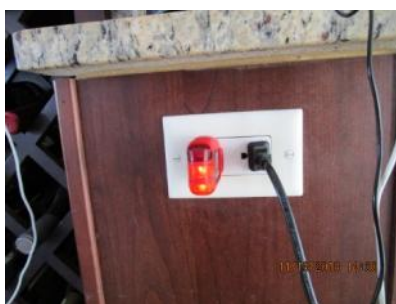
**4.25** Counter GFCI receptacle outlet (W) tested ok; appeared generally sound.

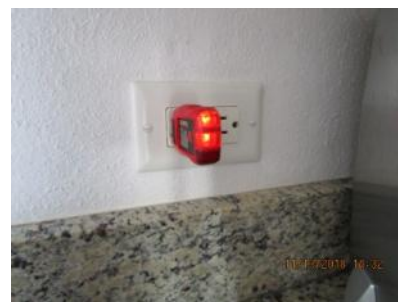
**4.29** Counter GFCI receptacle outlet (S) tested ok; appeared generally sound.

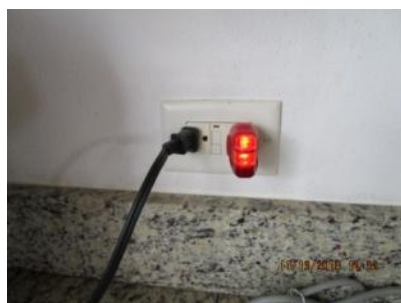
**4.30** Counter GFCI receptacle outlet (S) tested ok; appeared generally sound.

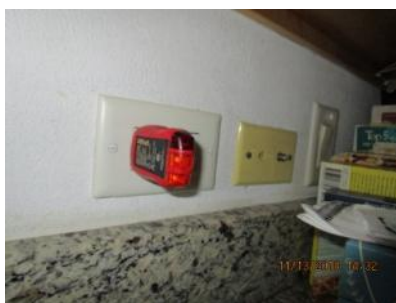
**4.31** Counter GFCI receptacle outlet (S) tested ok; appeared generally sound.

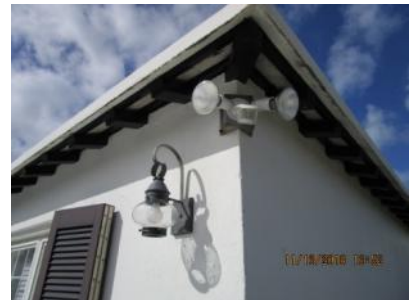
**4.97** Main entry fixtures appeared generally sound.

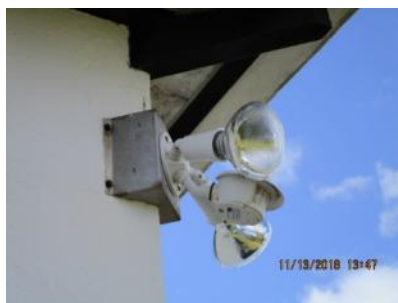
**4.107** Fixture (W) appeared generally sound.

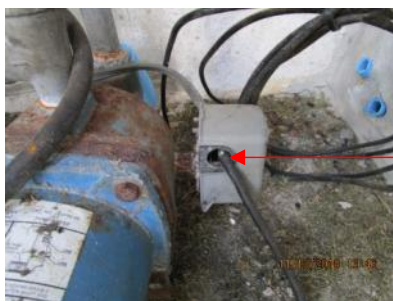
**5.3** A cable connector is required to terminate the cord to the pressure switch.

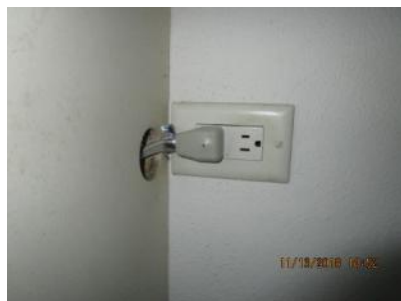
**5.14** However, a rated disconnect switch should be installed for the water heaters rated 120V rather than the receptacle and plug option due to their high amperage output.

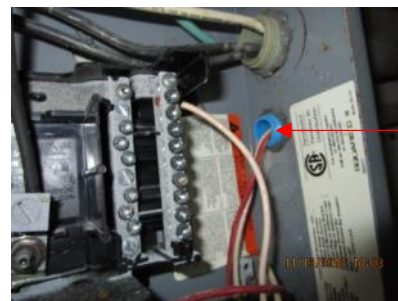
**6.2** Circuits and Conductors in the pool panel appeared generally sound. However, a ground conductor is needed for this conduit as per code.

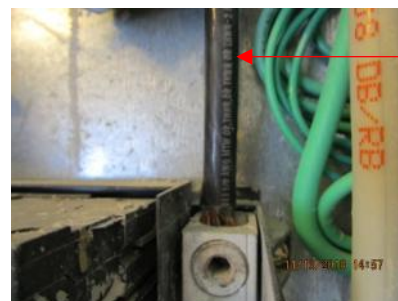
**6.5** The main feeder serving the laundry panel is a 1/0 AWG Conductor which is rated at 170A. The main 200A breaker at this point should be reduced to 150A to prevent overloading of the conductors.

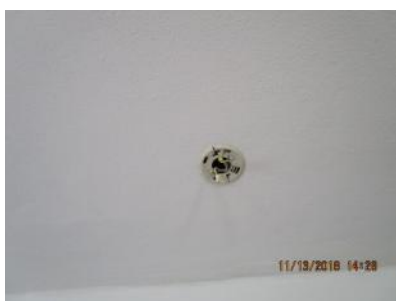
**6.7** All missing smoke detectors need installing as per code.

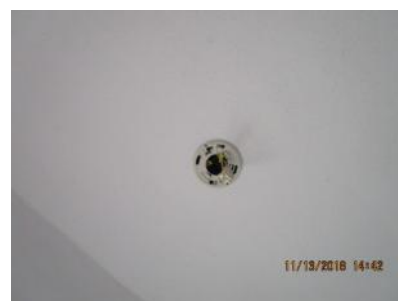
**6.8** All missing smoke detectors need installing as per code.
